# Report on failure of 400/220kV/33kV, 315MVA Transformer (BHEL make) at Bamnauli Substation of Delhi Transco on 11-02-2008

The 400/220kV/33kV , 315MVA transformer no 1 (BHEL make) failed on 11-02-2008 at 20:40 Hrs at Bamnauli substation..

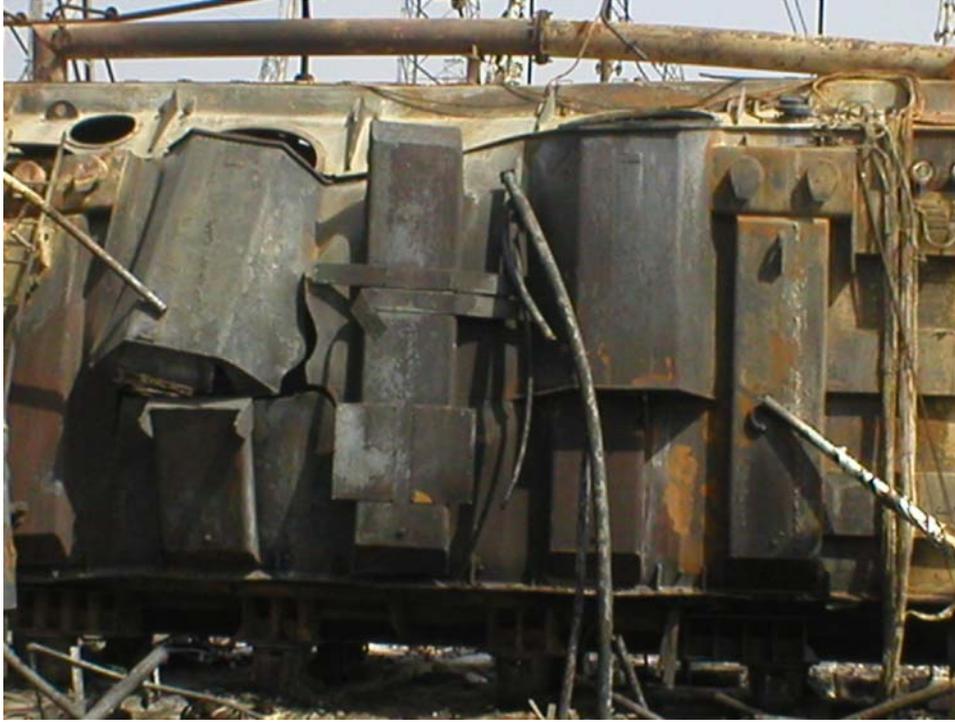
The **315 MVA 400/220/33 kV transformer** burst into flames and was totally damaged.

- (g) As per site inspection it was observed that the transformer got damaged completely and was beyond repair. This damage might have been caused due to the sudden jerk on the winding/core. This is evident from the photographs attached.

Damaged Transformer

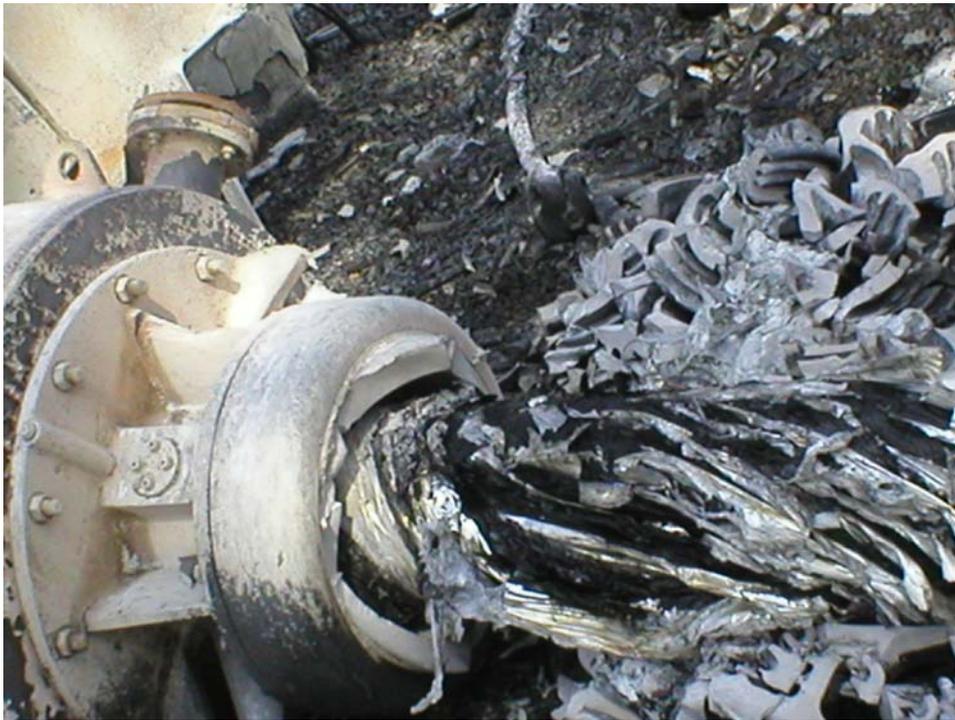
Damaged Bushing

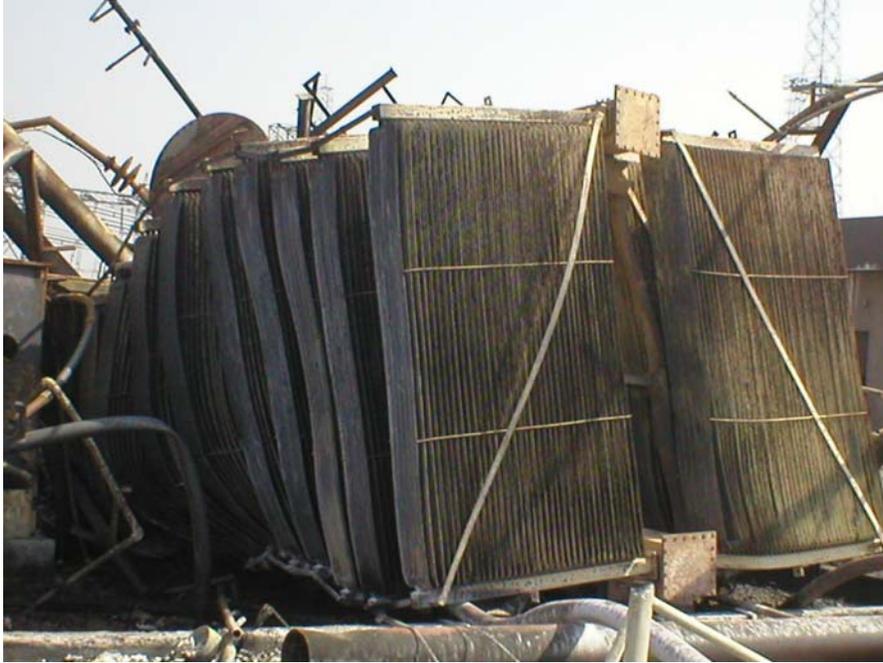
Damaged Radiator Bank

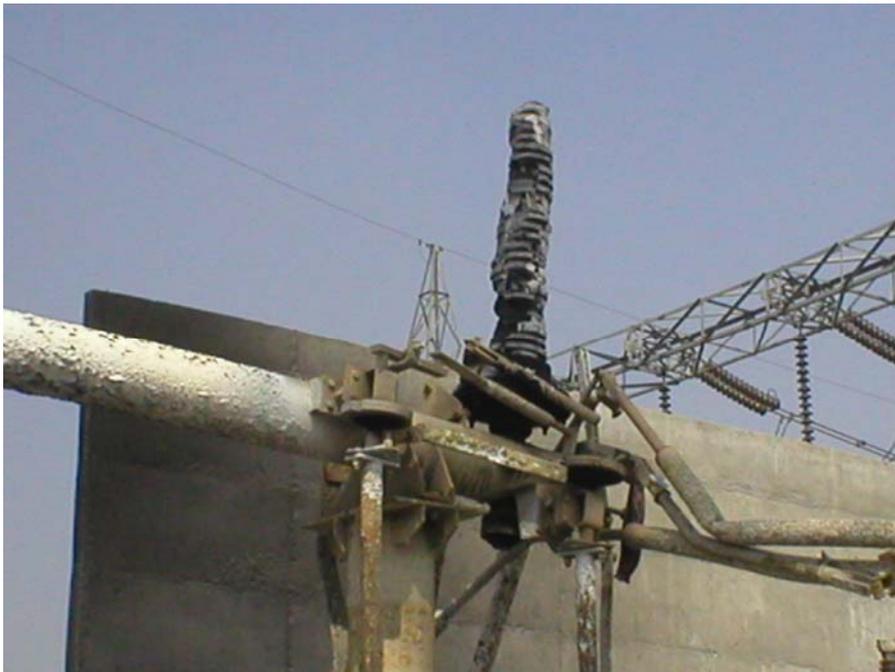
(b) Surge Arresters, 390kv -- 3nos.

Damaged Lightning Arrester

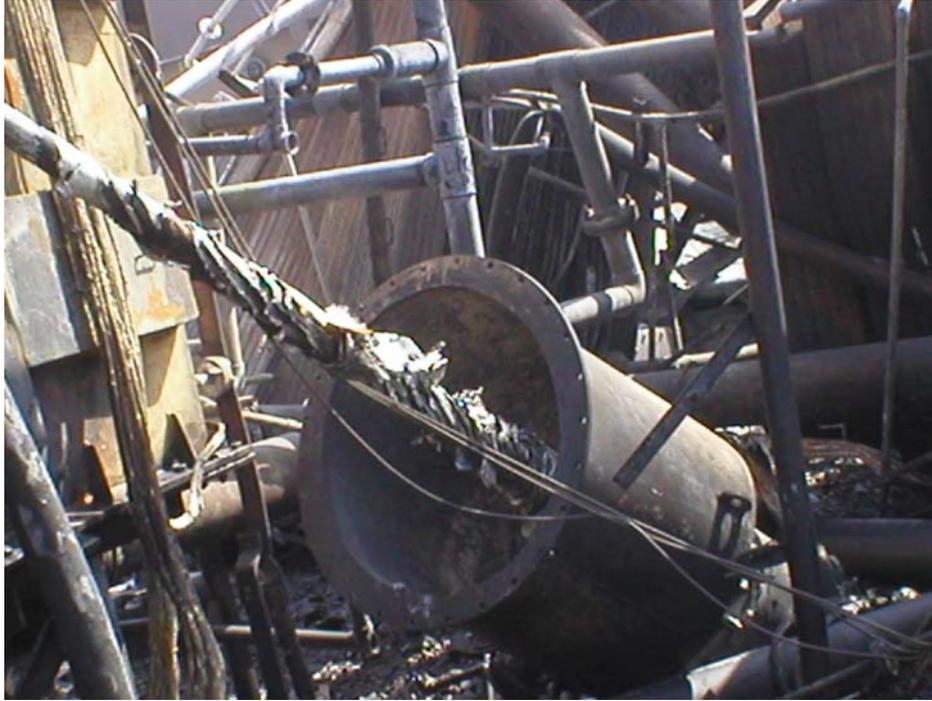
Damaged Bushing

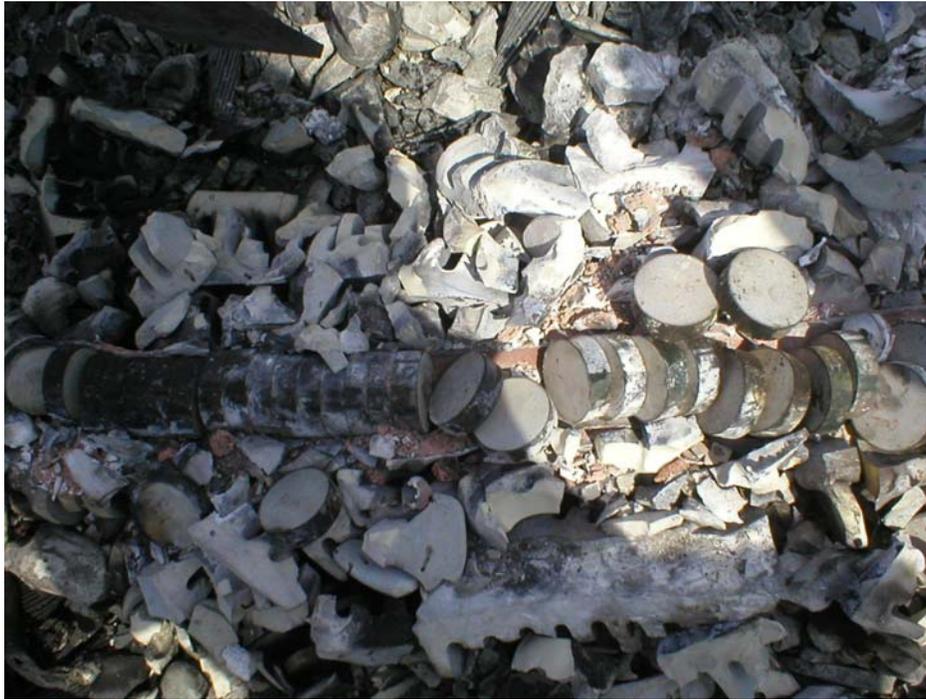
(c) Surge Arrester 216 kV,-3nos

Damaged Lightning Arrester

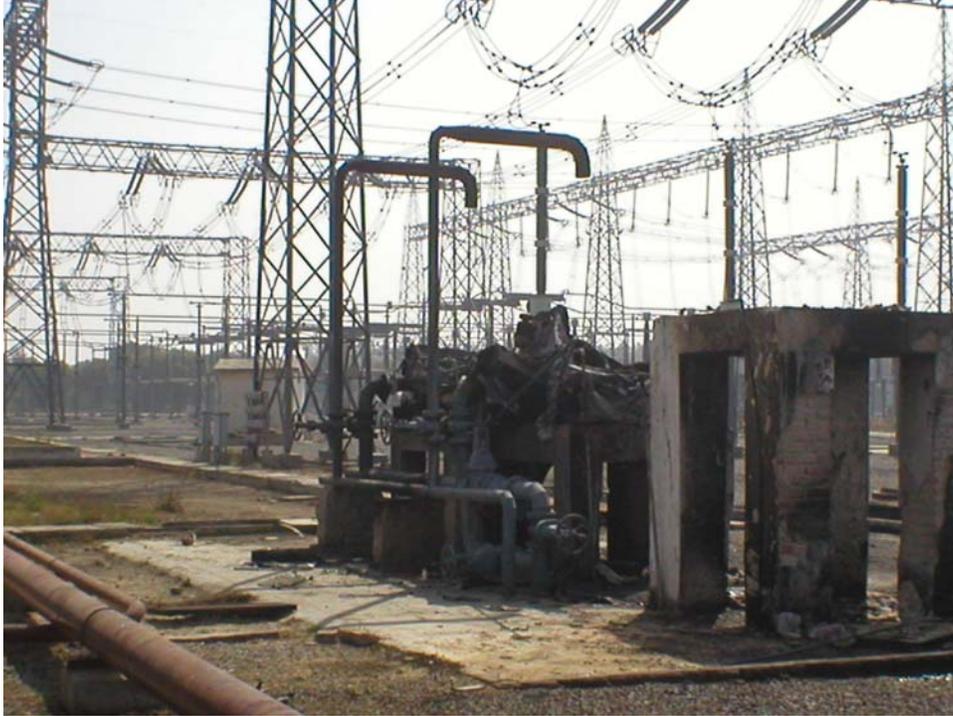
In addition to above a cooling tower of A/C plant was also got damaged.

Damaged Cooling Tower

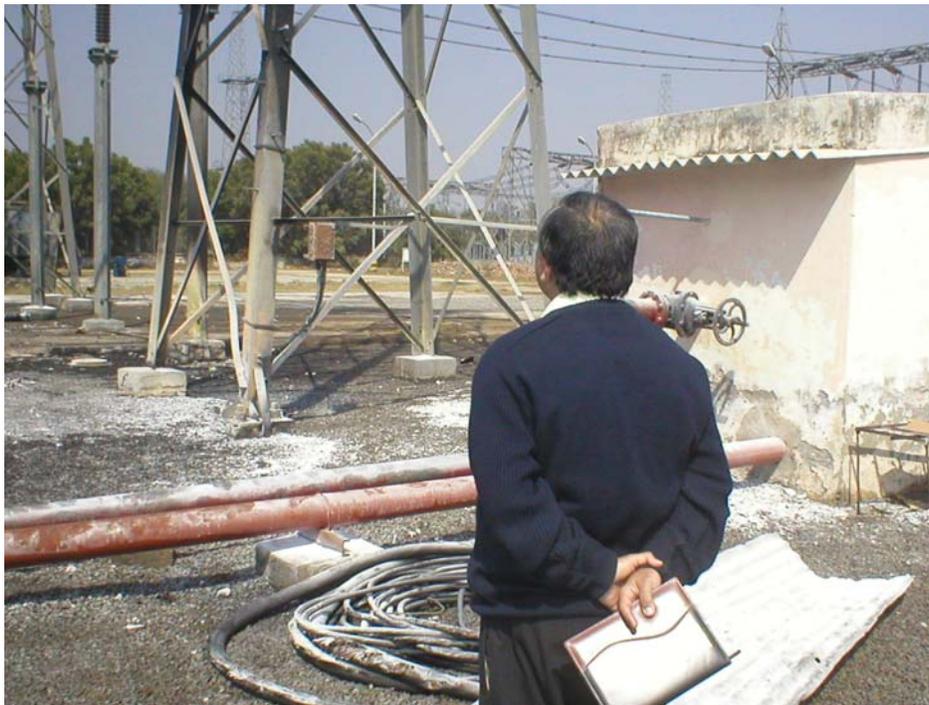
(a) All the associated power and control cables

Damaged Cables

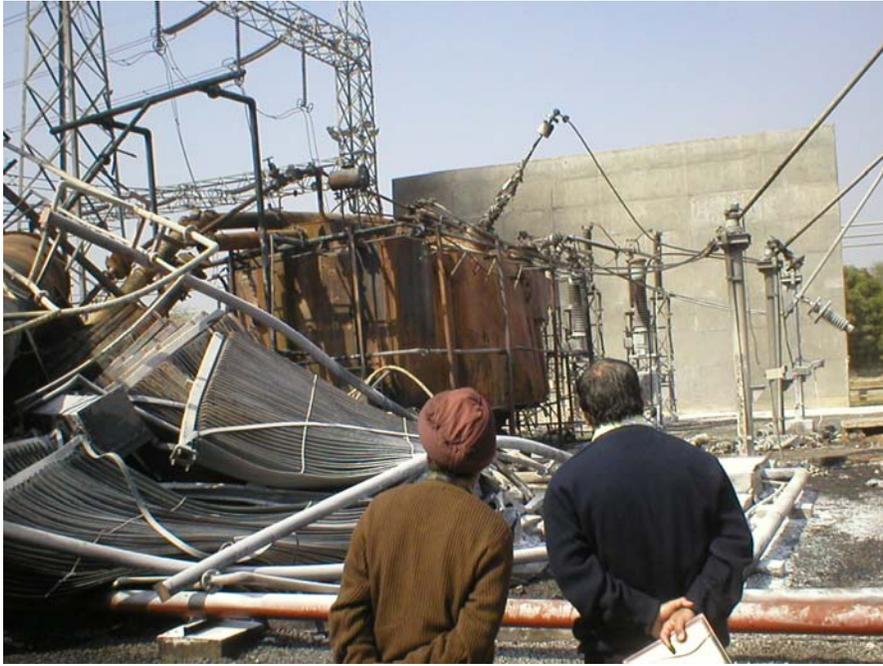
Damaged 220 kV Site Bushing
